Manhole Inspection Summary

Manhole # S23CC1034MH

Insp Date: **5/31/07 1:21 PM**

Location Address: **3660 BUENA VISTA AVE**

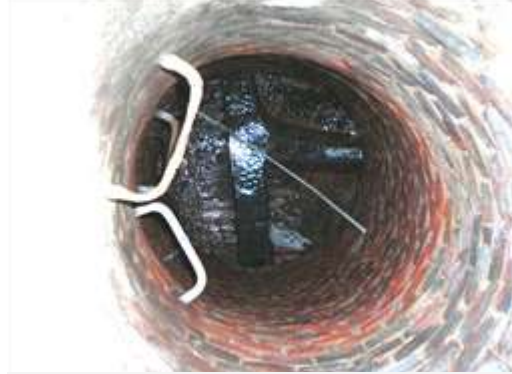
Top View

Corroded and missing steps. Evidence of surcharge - Bench debris.

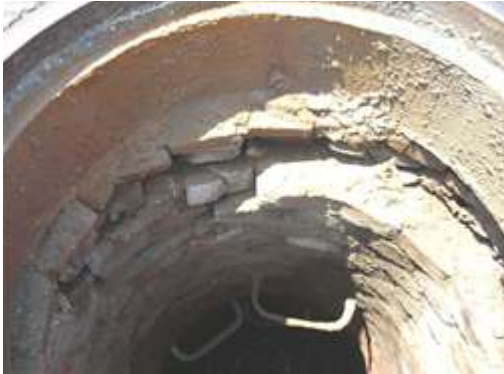
Defect

Frame leaks. Adjustment loose brick, deterioration and infiltration.

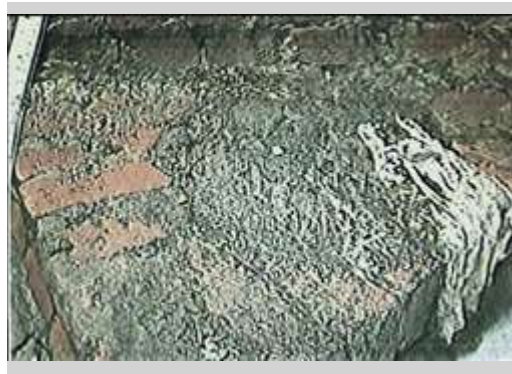
Defect

Barrel and Channel deterioration.

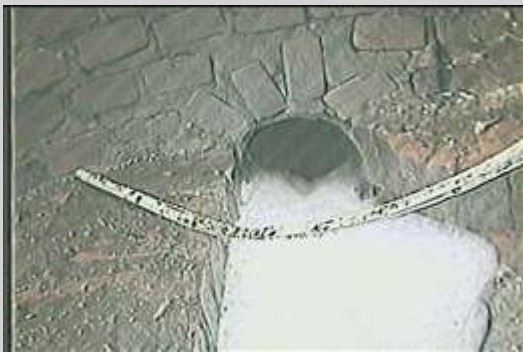
8 in. Circular Gravity Sewer Pipe Out @ 12 O'Clock

Infiltration: **Evidence** Pipe Seal Cond: **Cracked**

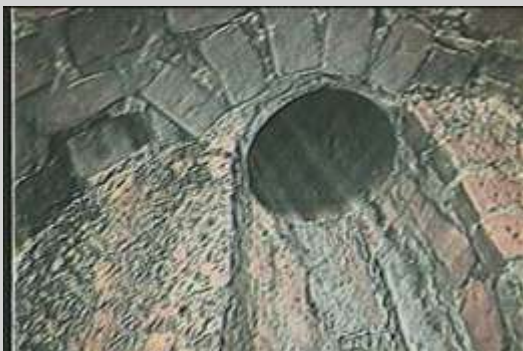
8 in. Circular Gravity Sewer Pipe In @ 3 O'Clock

Channel deterioration.

Infiltration: **Evidence** Pipe Seal Cond: **Cracked**

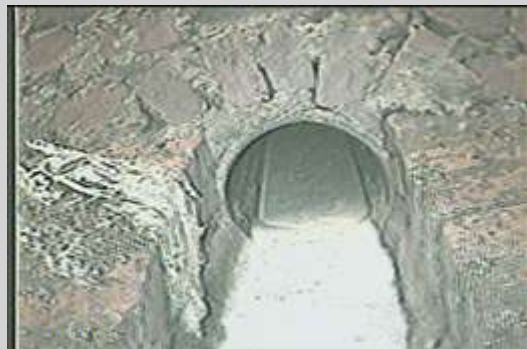
8 in. Circular Gravity Sewer

Barrel deterioration and infiltration.

Pipe Seal Cond: **Cracked**
